BRANCHLINES

SEPTEMBER. 2005

Newsletter of the Canterbury Railway society Inc.
PO Box 13-039, Armagh, Christchurch, New Zealand.
Web site: <http://www.trainweb.org/ferrymeadrail/>

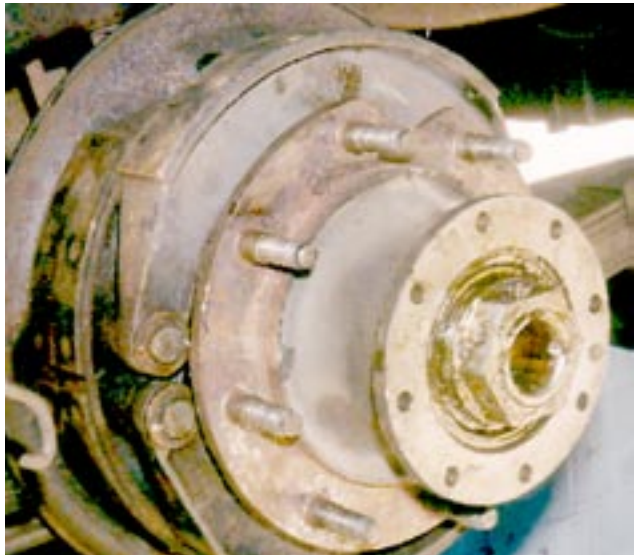
Not a great picture, but you can pick out those two sets of shoes, the outer being the hand brake set. The slave cylinder is at the top and behind the inner shoes.

The brake drum is a dreadful weight and takes two to get it into place.

The rear brakes were quite a can of worms too. When finally opened up, it was found that the hand brake was an entirely separate set of shoes within the drum, operated only by the long handbrake lever. All the shoes had to be removed to get at the rear slave cylinders and that was a job on it's own.

Every Thursday, the unit would appear in the workshop and a wheel would be removed to get at the brake gear. This was the routine for many weeks as the system was reworked. Some wheel nuts had frozen to the studs and had to be gas cut to free them. This necessitated new wheel studs, the heads of which fouled the brake shoes, with the subsequent grinding back of the heads to give clearance.

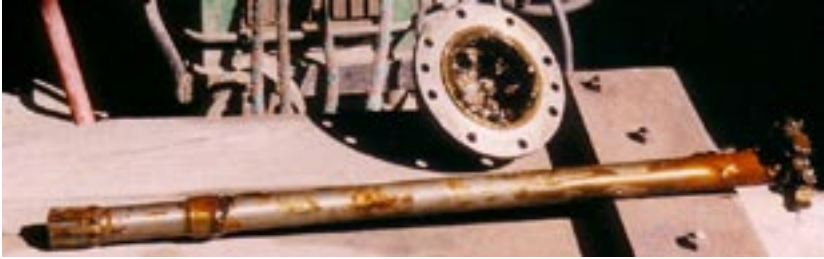
Of interest too, is the way the axle (half shaft) drives the wheel hub. It was certainly new to all of us. The outer end of the axle does not have the usual flange that bolts to the wheel

hub. Instead, it ends in a star shaped set of dogs that sit within a matching recess in the outer flange that bolts on separately.

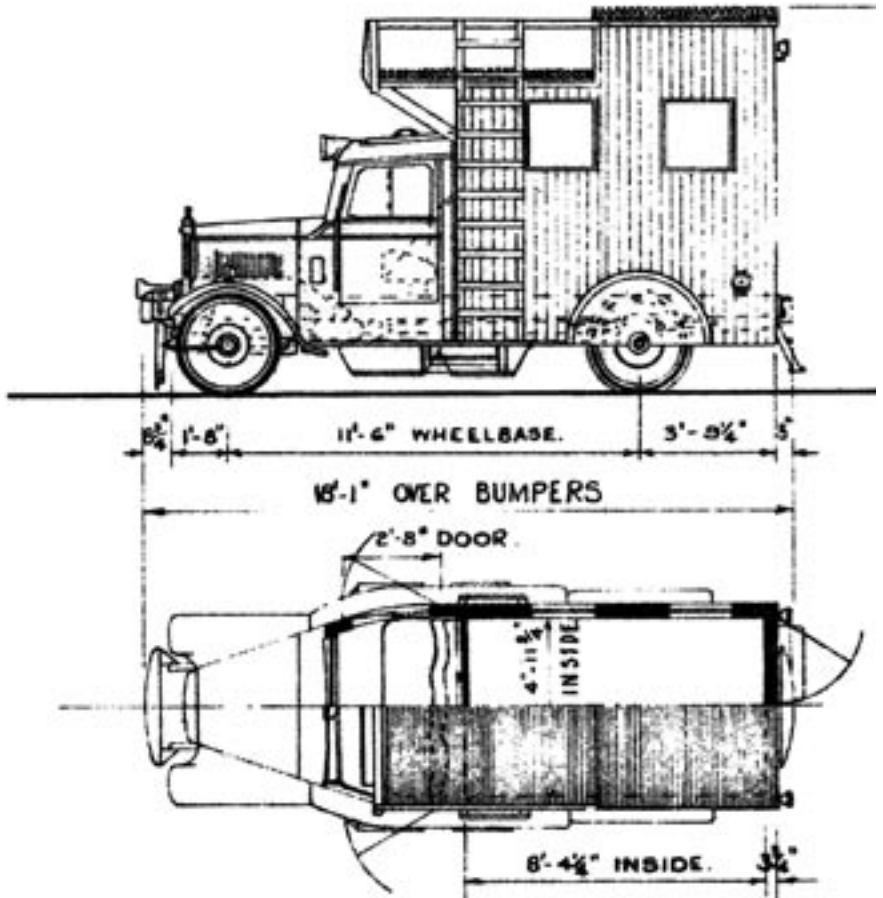
Herewith another drawing from Colins archives, showing the Red Terror in its present guise. The condition of the whole vehicle is very good. The timber construction of the addition for overhead servicing has lasted well. What is not readily seen, is

the turntable underneath the vehicle, for turing it about at thend of each run. This too has been reconditioned. The front doors are all but finished and we look forward to seeing the vehicle completed before too long.

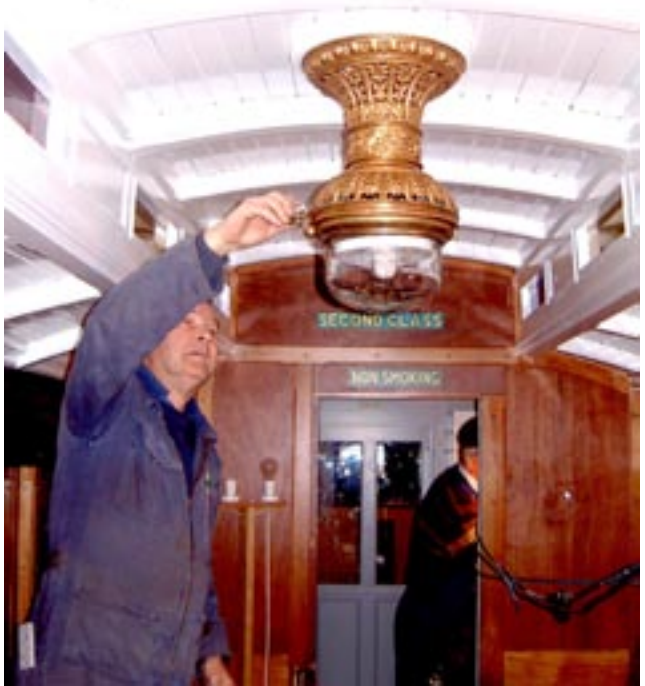
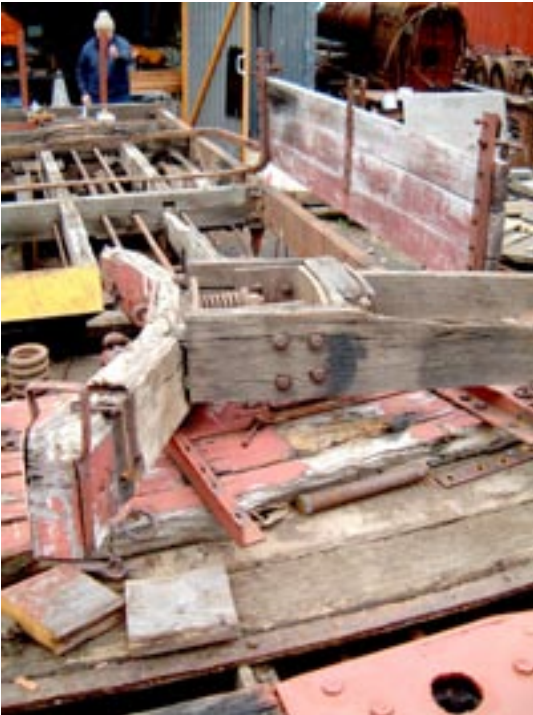
'B231'. The Gas Lamps have just been installed.

Keith Brown tries the gas adjusting handle for size.

In the guards compartment, we see Graham Inwood hunting in the pigeon holes on the wall for some very small screws. It is to be hoped he finds them before we commission it on Labour Weekend.

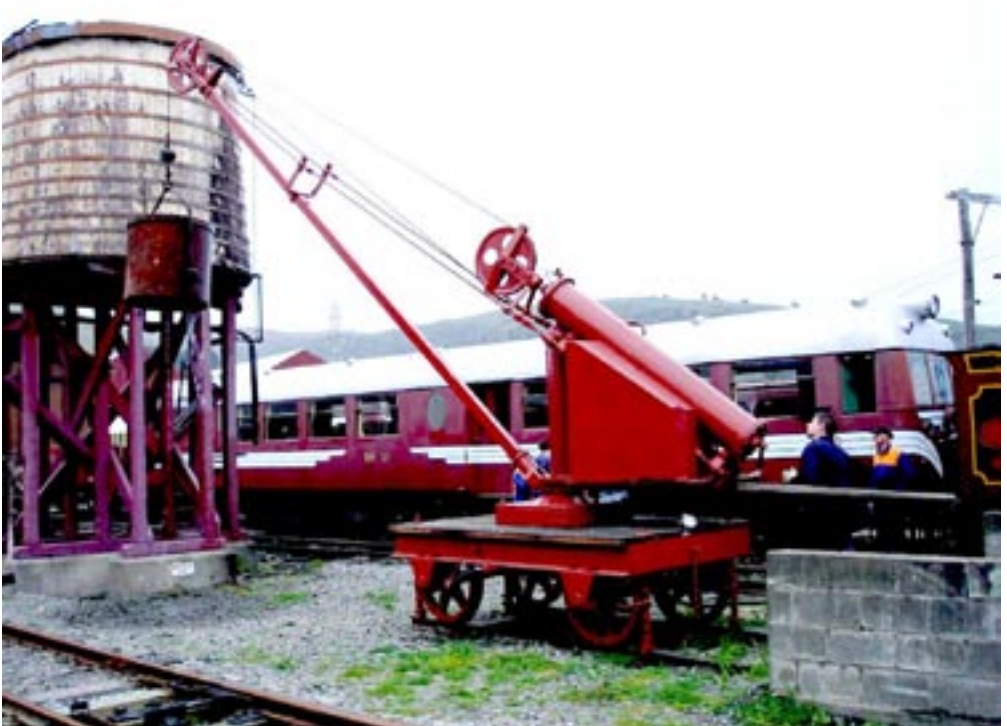
On a recent Saturday, when 'W192' was fired up after it's winter survey, it was decided to use the on board compressor to test the coaling crane that had been overhauled earlier in the year. The crane has been out of use for some time, as the locomotives in use, don't lend themselves readily to the use of the buckets on the crane

Rather than using coal in the bucket to add weight, the simple expedient of blocking the drainhole and filling it with water was used. After a rather erratic start, it settled down and finally was working well other than a

slight leak-down if left with the bucket raised for some time. The picture is not highly defined I'm afraid, but I'm sure you will get the general idea and it's thanks to Nigel that we even have a picture to show.

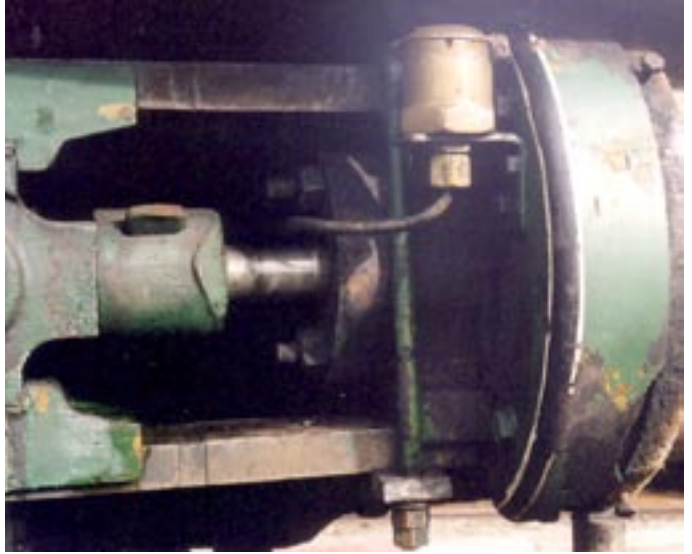
F13. Showing the 'U' bolt that was used to make do after the lower guide bar bolt was stripped out of the cylinder end cover. I doubt it would get certified with such a device in today's world. The crosshead was very slack in the guide bars too. In fact, the engine was well worn everywhere and had long been in need of the rebuild it is now getting.
